Manhole Inspection Summary

Manhole # S09EE2011MH

Location Address: **2500 GREENSPRING AVE**

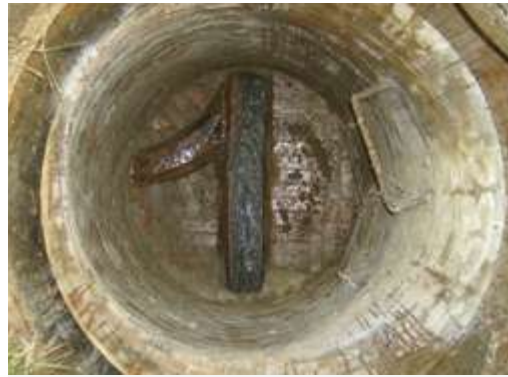
Top View

Infiltration: ☐ None ☒ **Joint** ☐ Cracks ☐ Mortar ☐ Roots ☒ **Wall**

Infiltration: ☐ None ☐ Joint ☐ Cracks ☐ Mortar ☐ Roots ☒ **Wall**

☐ Parged ☒ **Debris** (not Condition related)

Adjustment and Barrel infiltration. Bench debris.

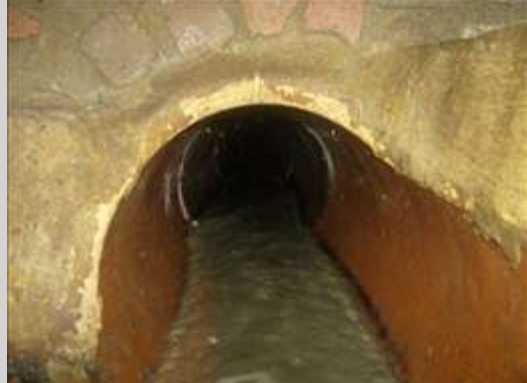
10 in. Circular Gravity Sewer Pipe Out @ 12 O'Clock

Pipe Material: **Clay** ☐ Pipe Lined

Invert Depth: **8.40** (ft.) Flow Characteristics: **Slow**

Deposits: ☒ None ☐ Mud ☐ Sludge ☐ Debris ☐ Grease

Infiltration: **None** Pipe Seal Cond: **Unknown**

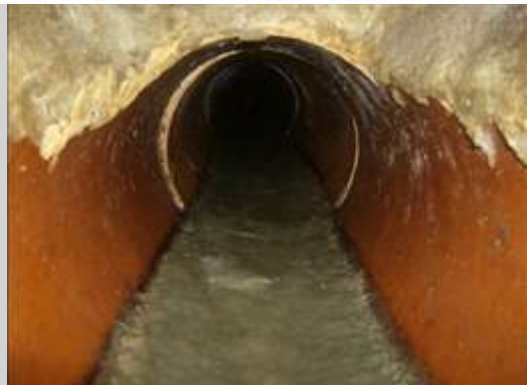
10 in. Circular Gravity Sewer Pipe In @ 6 O'Clock

Pipe Material: **Clay** ☐ Pipe Lined

Invert Depth: **8.32** (ft.) Flow Characteristics: **Slow**

Deposits: ☒ None ☐ Mud ☐ Sludge ☐ Debris ☐ Grease

Infiltration: **None** Pipe Seal Cond: **Unknown**

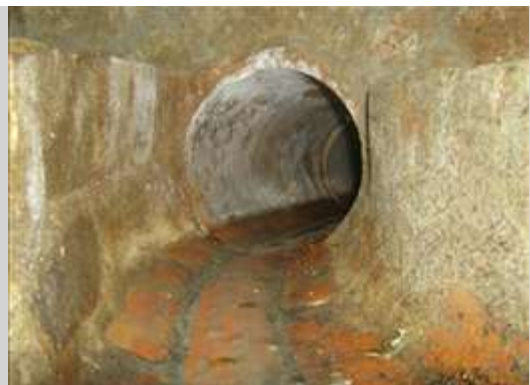
8 in. Circular Gravity Sewer

Pipe Material: **Clay**

Invert Depth: **8.03** (ft.) Flow Characteristics: **Slow**

Deposits: ☒ None ☐ Mud ☐ Sludge ☐ Debris ☐ Grease

Infiltration: **None**
